Subject: Safety Recall 00V-246.111 NSA-11paw
(Ford Number 00S48)

SUBJECT: Safety Recall 00S48: Certain 1999 and 2000 Model Year F-53 Motor home Stripped Chassis, F-650, and F-750 Trucks Equipped with size 20 EDL TRW Tie Rod and Drag Link Ball Sockets – Tie Rod Ball Socket and Drag Link Inspection

DRAG LINK AND TIE ROD END INSPECTION AND REPLACEMENT

AFFECTED VEHICLES: CERTAIN 1999-2000 MODEL YEAR SUPER DUTY
MOTORHOME CHASSIS (MODEL CODE F-53), F-650
AND F-750

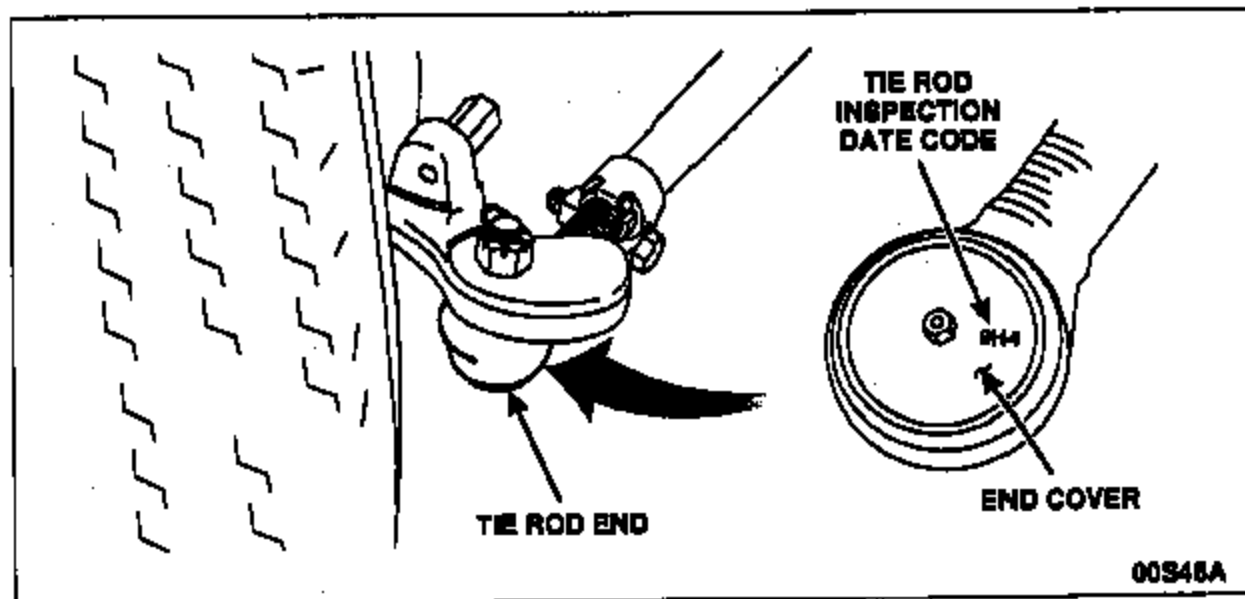
FIGURE 1

Locate the date codes stamped on the end covers of the tie rod ends. See Figure 1.

Compare the date codes to those listed in the Affected Date Code Chart on page 2.

- If either tie rod end date code is listed on the chart, replace both tie rod ends.
- If neither tie rod end date code is listed on the chart, tie rod end repair is not required.

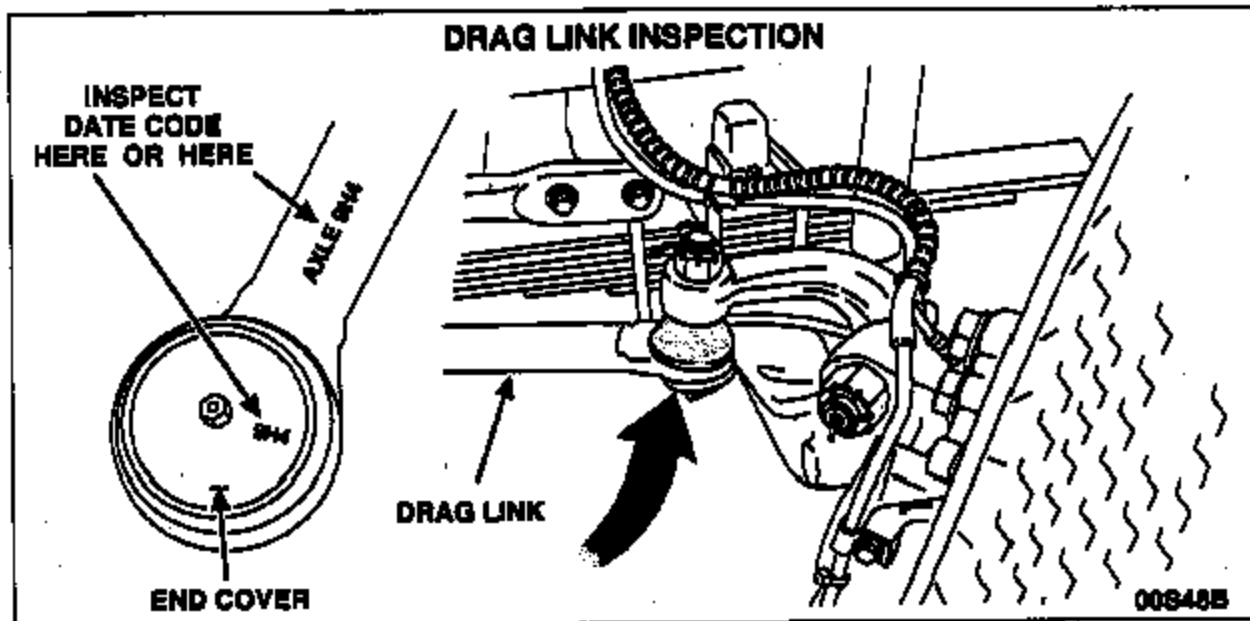
FIGURE 2

On F53 Motorhome only, locate the date code stamped on the end cover of the drag link or on the shaft of the drag link (next to the word "AXLE"). See Figure 2.

Compare the date code to those listed in the Affected Date Code Chart below.

- If the date code is listed on the chart, replace the drag link.
- If the date code is not listed on the chart, no drag link repair is required.
